As Vic High's bones are revealed, all involved in the project agree...Vic High was built to very high standards with progressive building techniques and excellent workmanship.

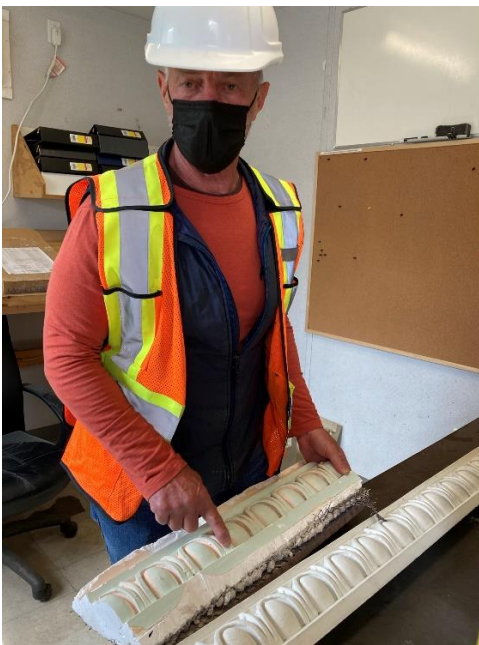
School District 61 on-site Project Manager Gord Wallace starts the tour by showing us some ceiling trim samples being prepared to replicate trim uncovered during demolition. Samples of removed pieces are being kept for the Vic High Archives.

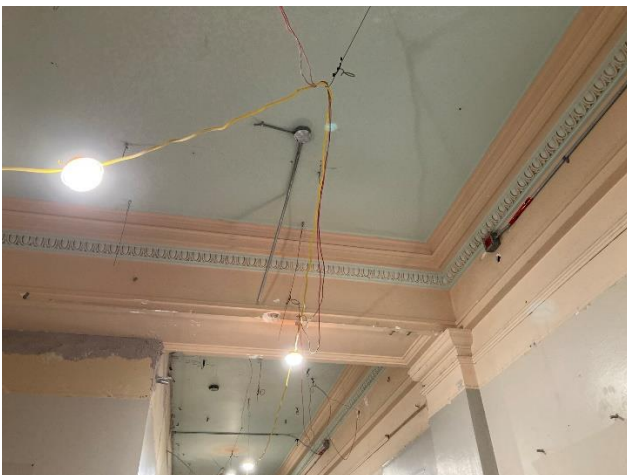
Original ceiling trim uncovered when false ceilings were removed. The plan is to replace it in the 2nd floor Heritage Corridor running east to west inside the main Grant Street entrance.

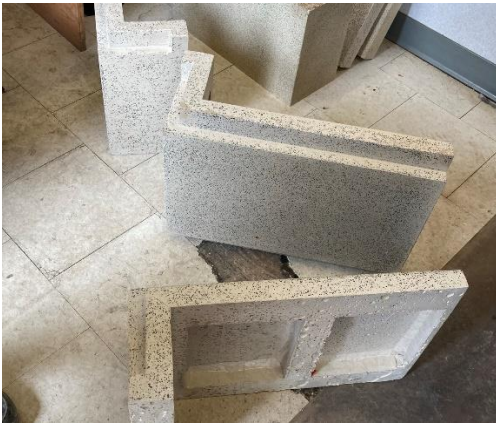
Samples of new high-density concrete block tiles to replace severely damaged terra cotta ones on the school's exterior. Despite the baked-on speckled finish, terra cotta is porous and absorbs moisture causing cracks and damage over the years. These concrete ones won't. Most tiles, though, are in very good shape, specially for being 107 years old.

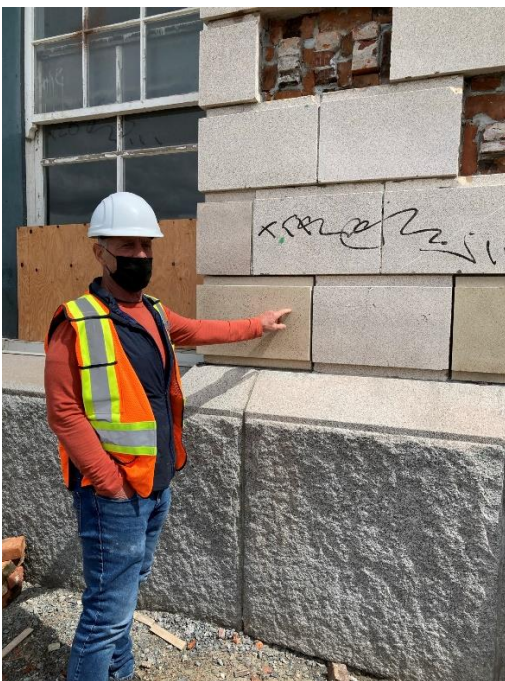
Wallace shows where sample concrete tiles are installed to check colour match. Each one is attached to a rod drilled into the tile sub-surface once its placement is lined up with special openings on the back of the tile.

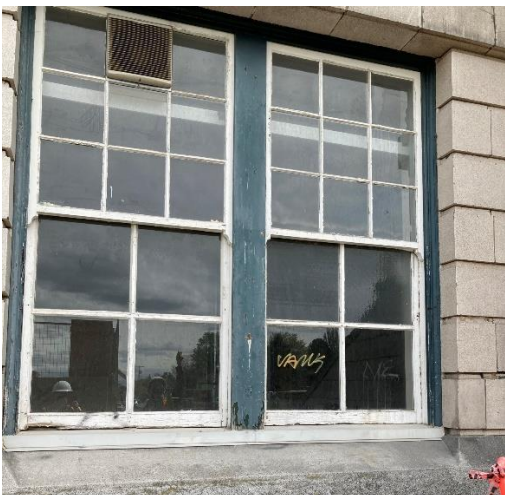
Window casings will get refurbished and repainted, or possibly replaced. All options are still under consideration. Exterior trim colours have not yet been chosen.

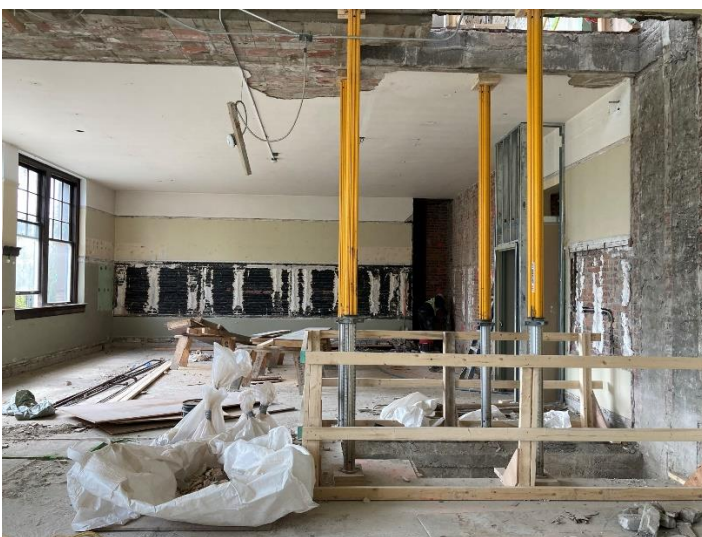
Big empty spaces everywhere. This is the west half of the 3rd floor library. Yellow jacks throughout the building provide load support while upgrading work goes on.

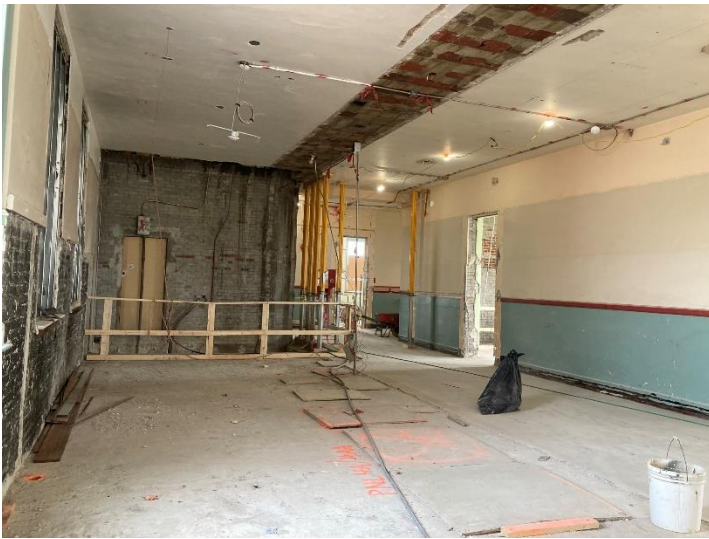
More empty spaces. This is the northwest side of the 4th floor. If you look closely, you can see in the doorway to a classroom, interior walls made of bricks.

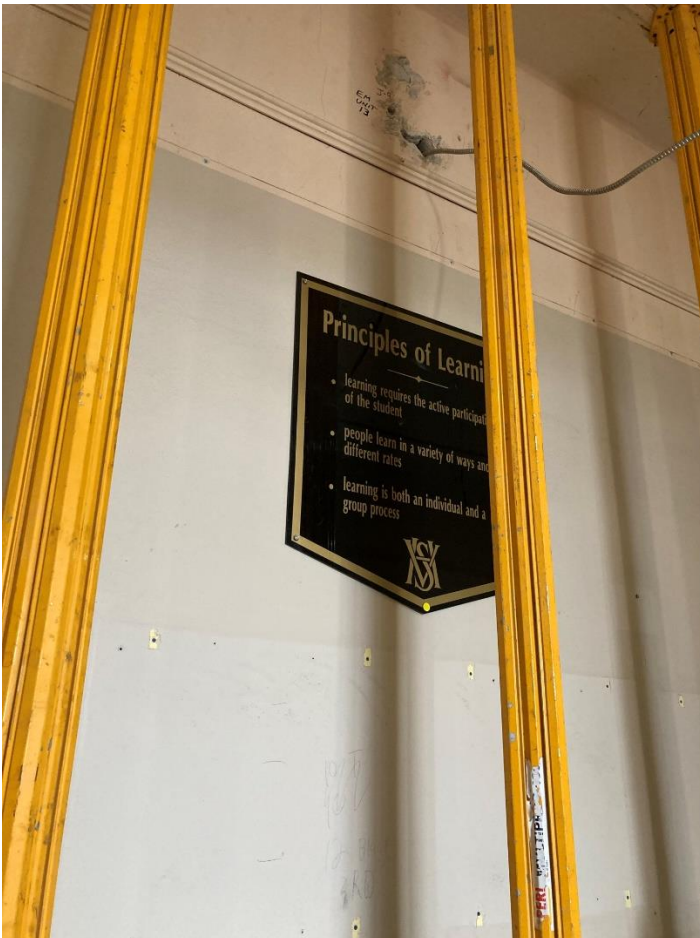
The old gal may be gutted and excavated with extra support everywhere, but her Principles of Learning stay firmly in place amidst all the chaos on a 3rd floor wall. Forgotten in the move-out?...or left behind for a reason?

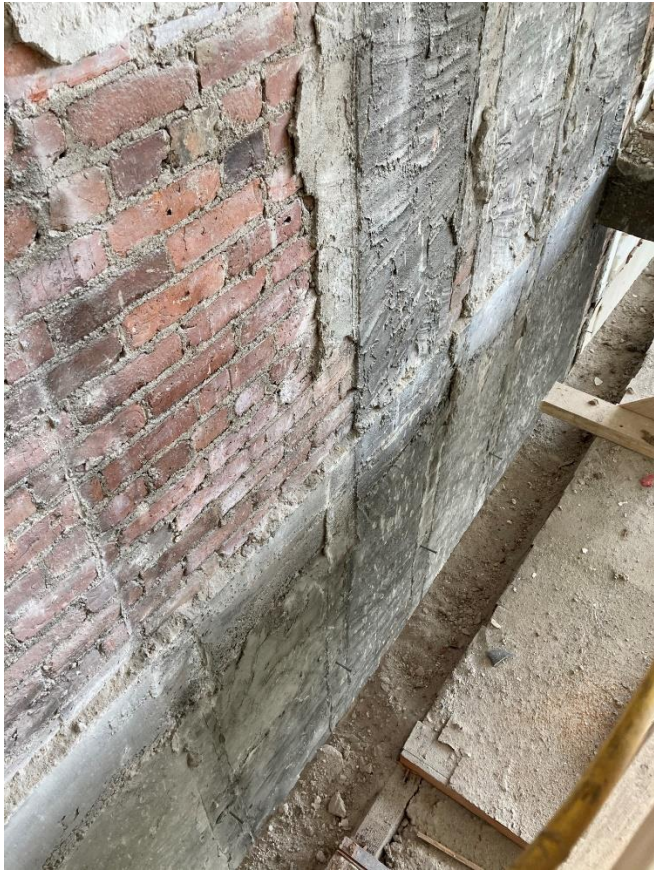
Interior brick walls look as strong and vital as the day they were installed. We know now, though, that earthquakes are a regional risk and these walls would not withstand a significant seismic event.

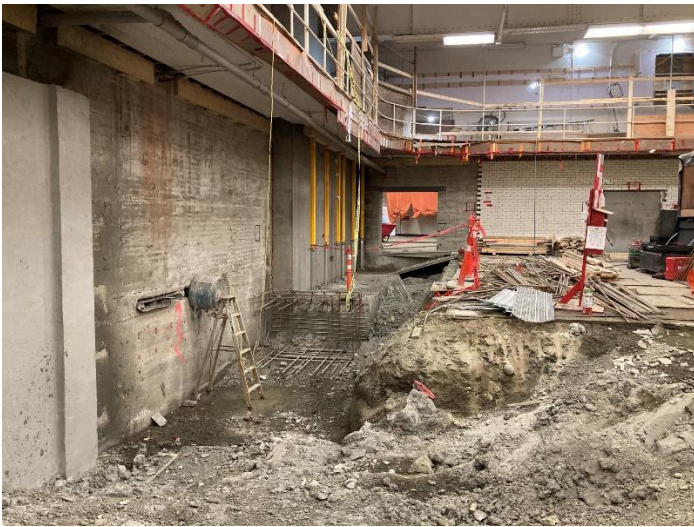
The Roper Gym west wall. Original footings are behind the ladder, about to be dug out and reinforced underneath now that new concrete shear walls are in place either side of it.

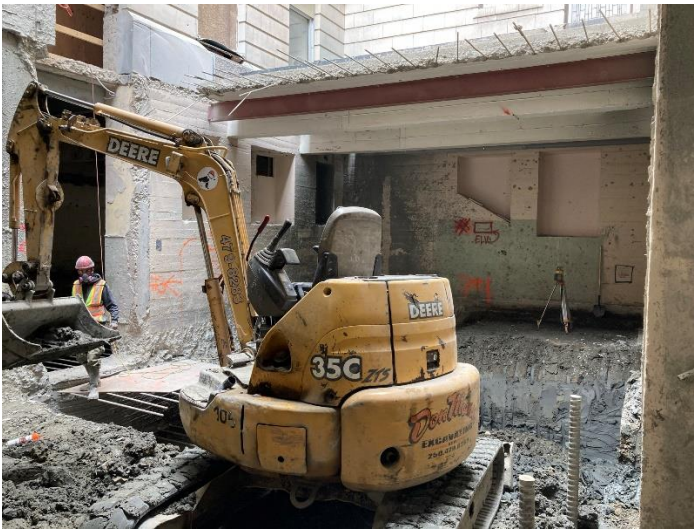
Excavating beyond the east wall and footings of the Roper Gym, ready to build shear walls.

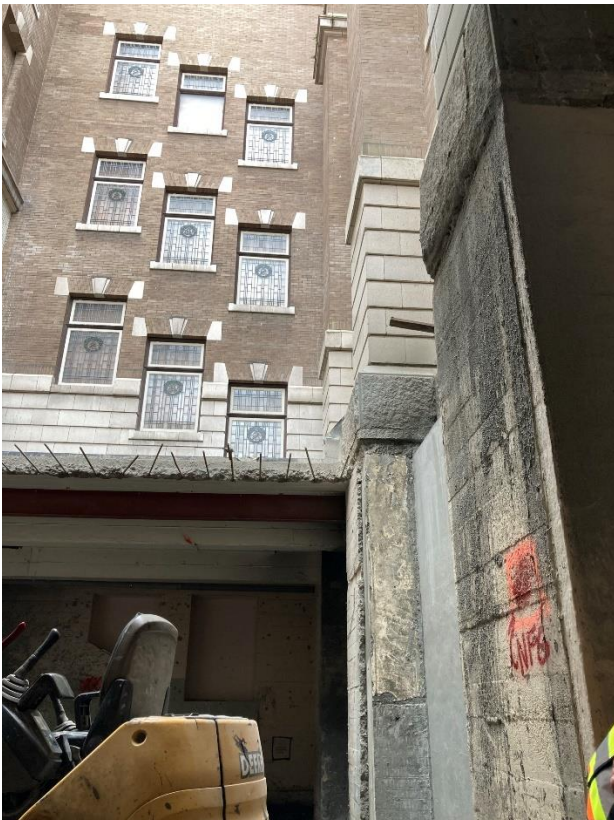
The exterior wall above the excavation site reveals the staggered stained glass windows that line each set of the South interior stairs. The original building was E-shaped (auditorium was in the middle bar of the "E"). The spaces either side were enclosed when the 1955 addition was built.

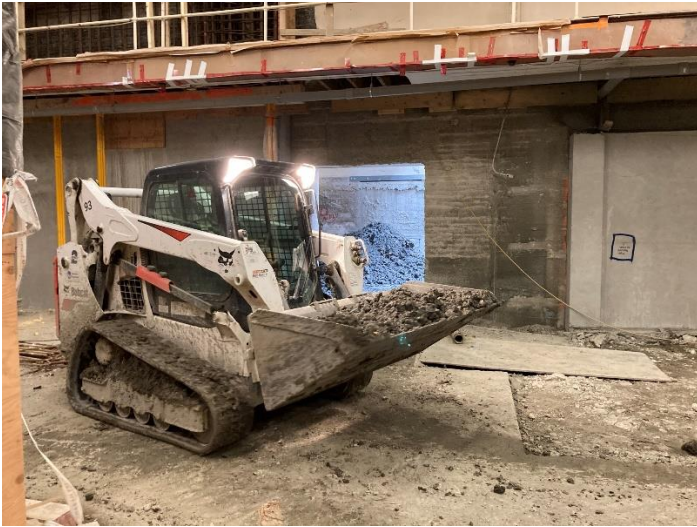
Small front end loaders, brought inside through openings created by removing sets of windows, remove soil and clay from the excavation site outside the Roper Gym east wall.

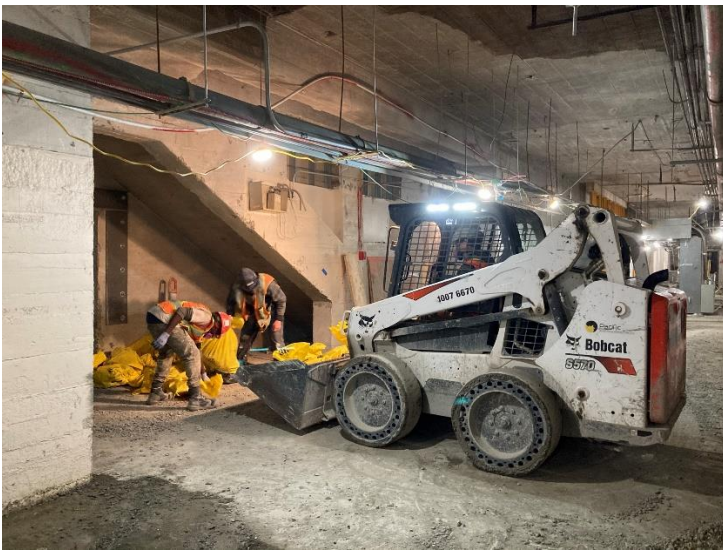
In smaller areas, excavation is done by hand and workers carry bags of soil to fill the bucket of a front end loader which then carries them out of the basement.

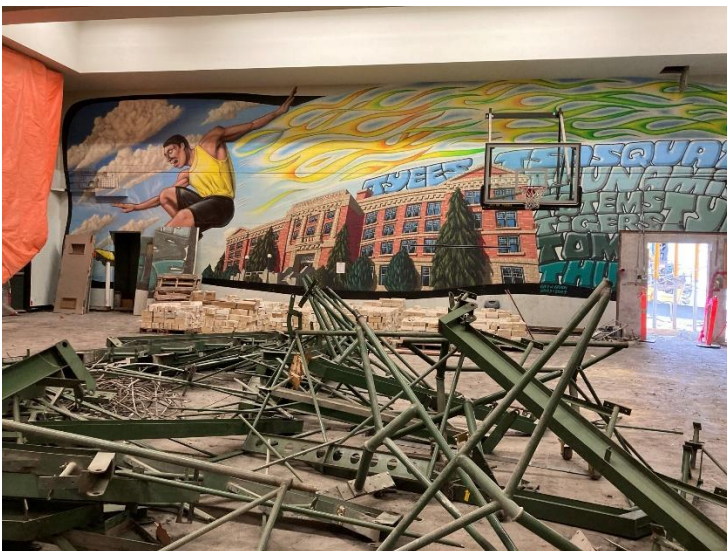
Framing for the old bleachers sits on the floor of the Andrews Gym waiting to be moved out. The flooring here was removed to allow removal of its creosote-treated plywood subfloor, which caused a curious odour over the years.

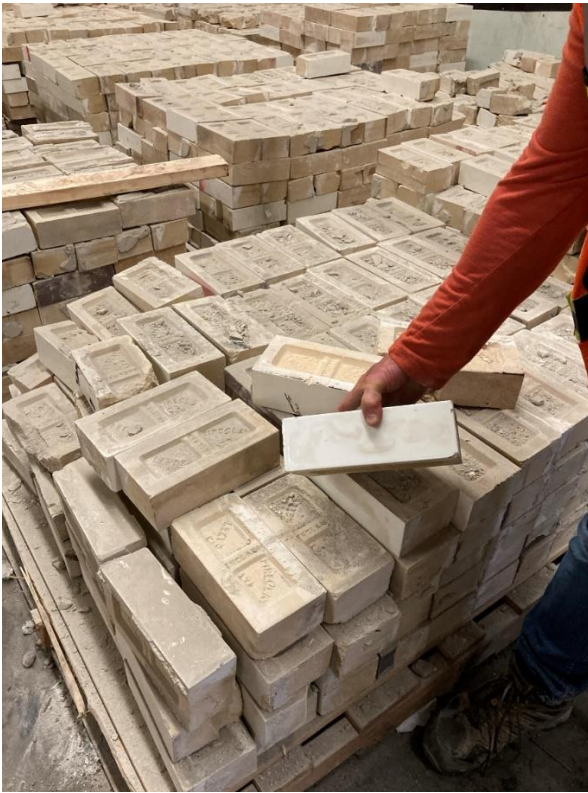
Hundreds of bricks were carefully removed from walls in the Roper Gym and await re-installation once the concrete shear walls are constructed. Their sides bear the shiny white baked-on finish we'd associate today with a flat ceramic tile. Original to the building, many are cracked or damaged and as they used to line all walls in the Gym, their reflective surface produced a significant echo. How many will be re-installed and where will be determined later.

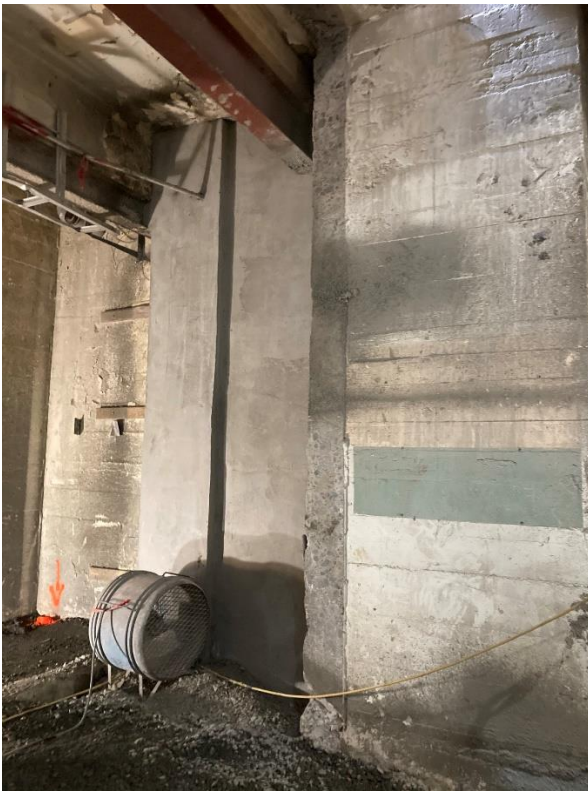
A new smooth concrete shear wall above the floor fan was built using interlocking rebar, then filled with shotcrete (concrete shot from a nozzle). With new basement-to-ceiling shear walls installed and taking the load, the original footings (to the right) can be excavated so reinforcing concrete can be installed underneath.
